June 28, 2019
File No. 262018.063

Subject: Department of Natural Resources Washington Geological Survey,
School Seismic Safety Assessment Project, Contract No. AE 410 -
Seismic Evaluation for **Ocosta School District**

Ocosta, Ocosta Elementary School, Primary Addition

Ocosta, Ocosta Junior Senior High School, Junior Senior High

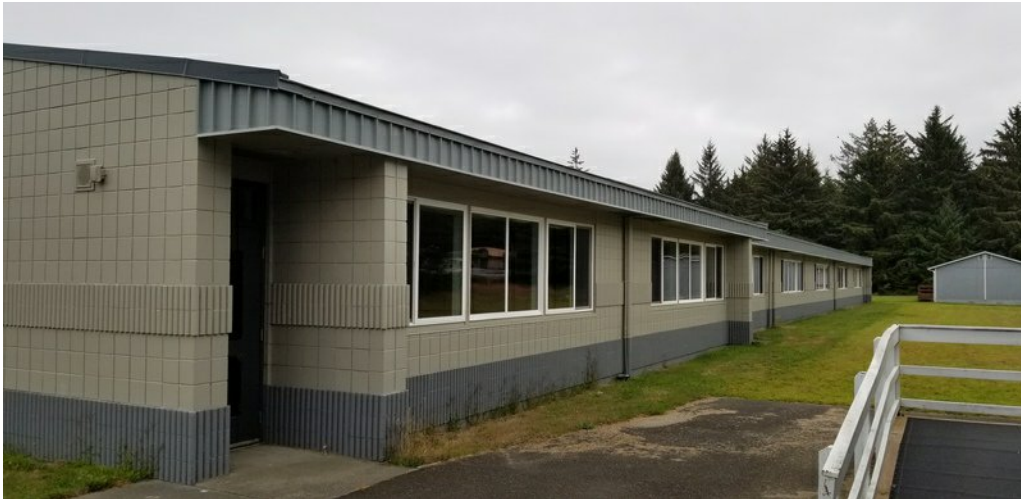
Figure 1-1. Typical exterior view

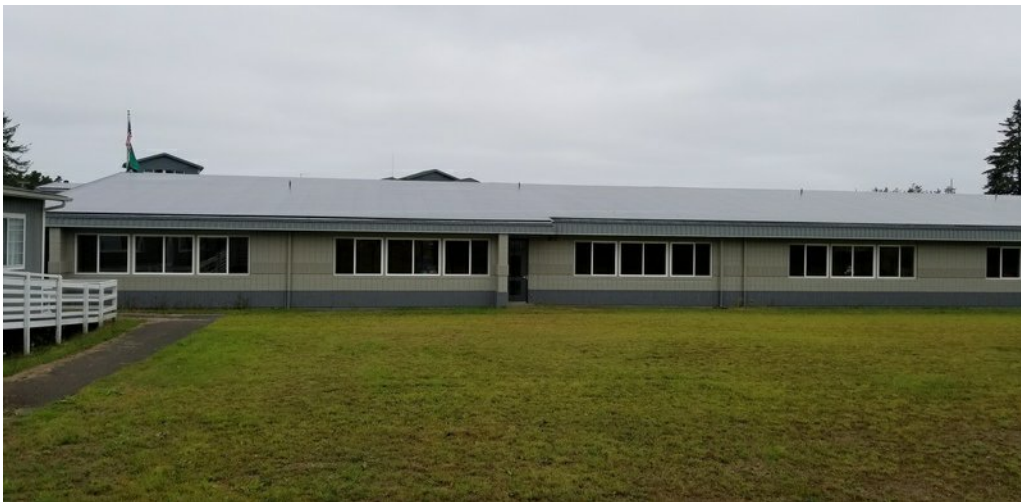
Figure 1-2. South elevation

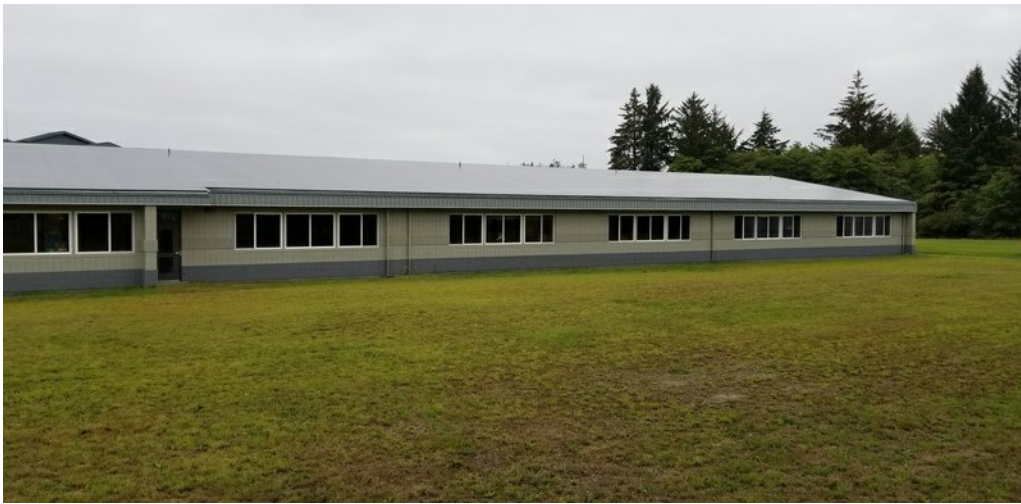
Figure 1-3. South elevation

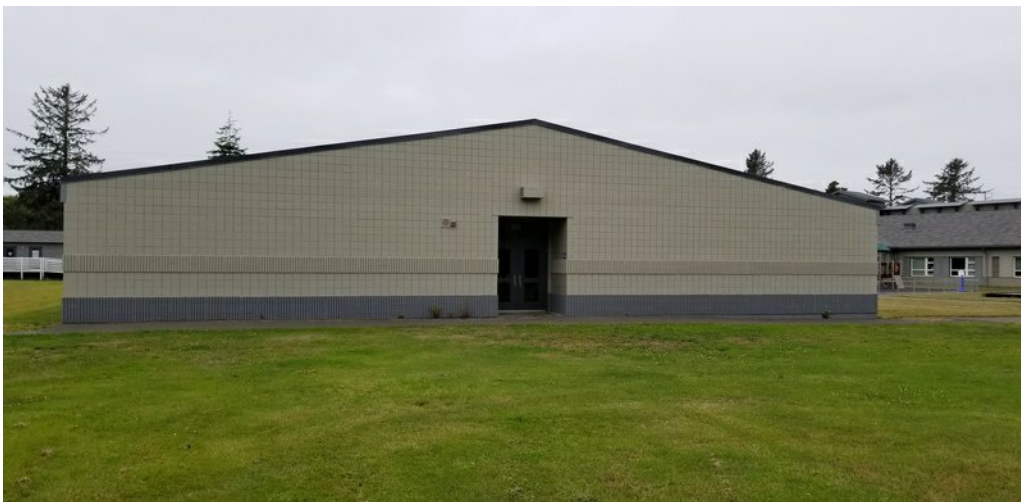
Figure 1-4. East elevation

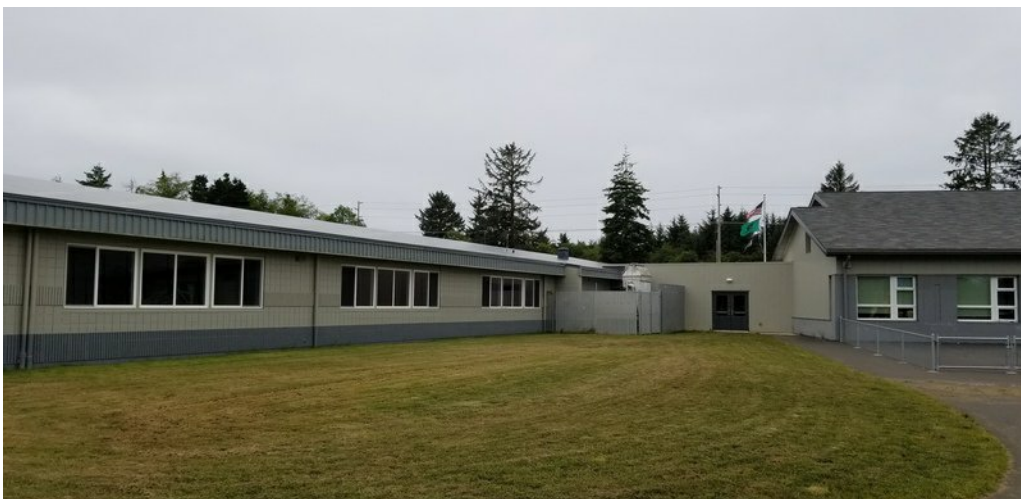
Figure 1-5. North elevation and mechanical yard

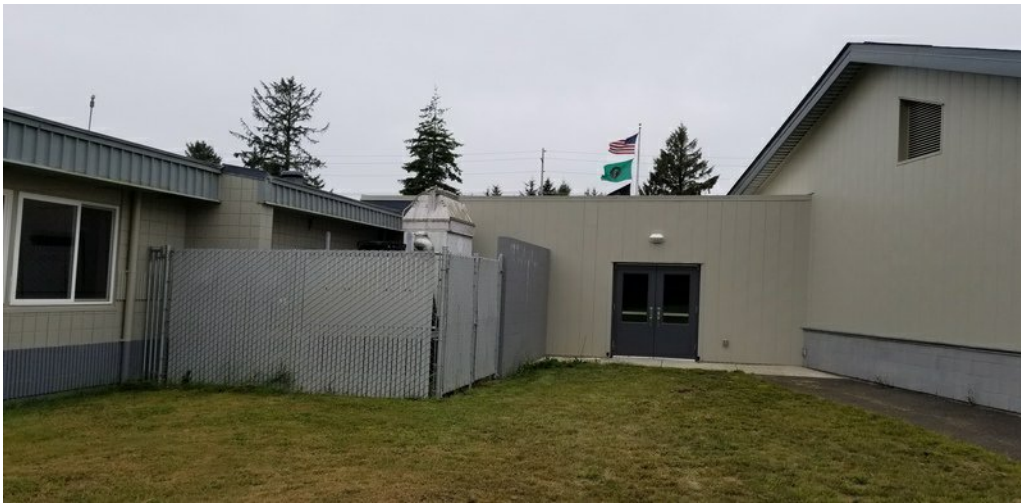
Figure 1-6. Mechanical yard and corridor connecting to new building

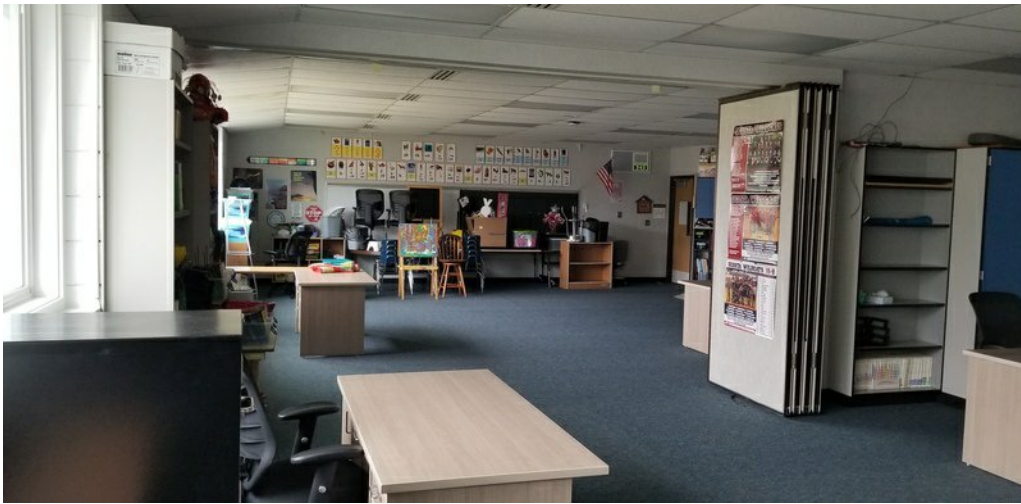
Figure 1-8. Typical classroom where fall prone contents and shelves should be braced

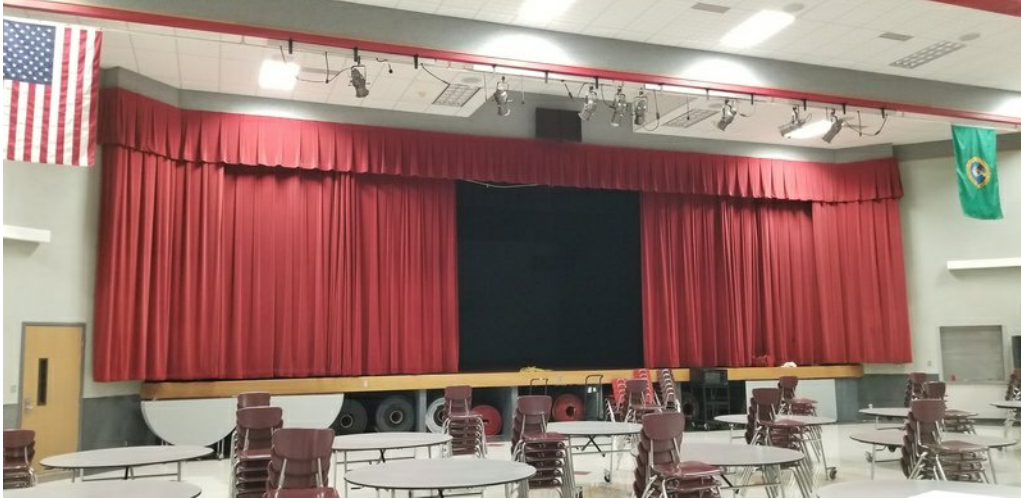
Figure 1-1. Dual purpose lunchroom and auditorium space

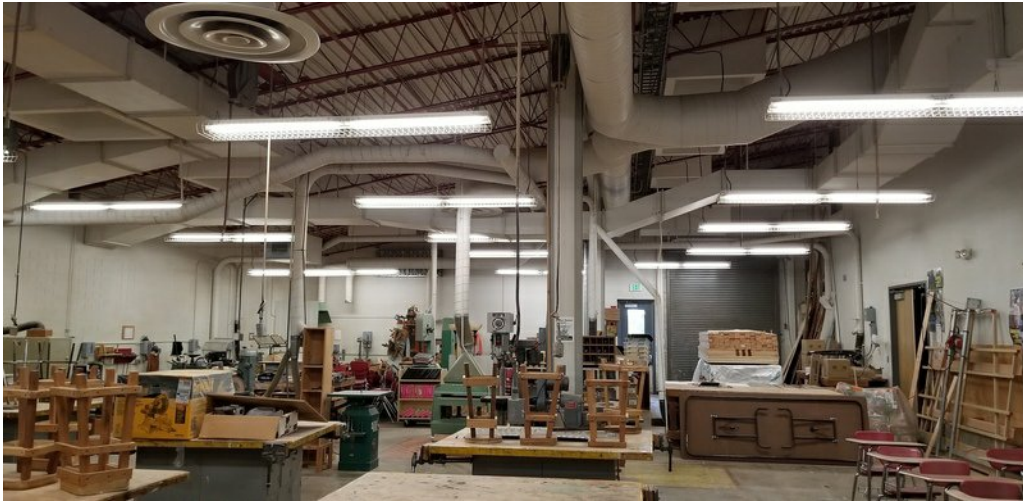
Figure 1-3. Ducting and equipment in shop should be braced

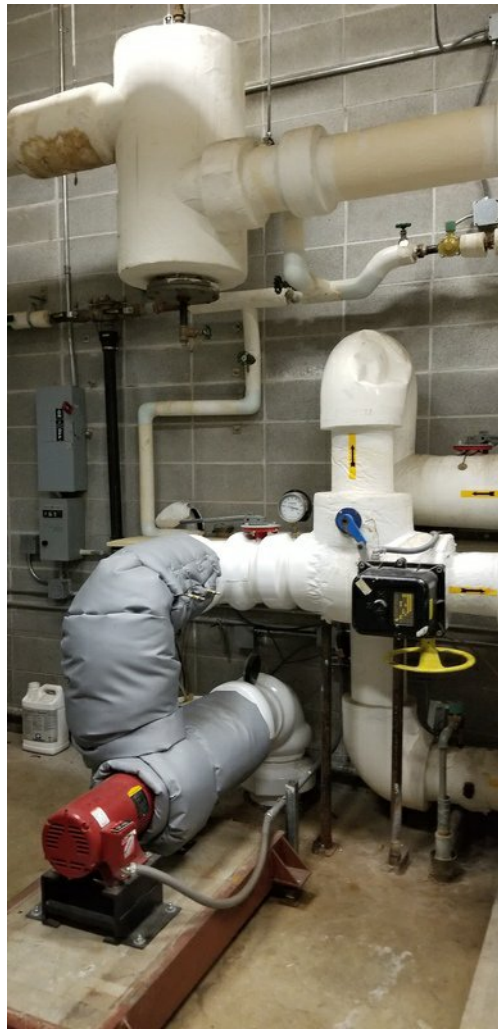
Figure 1-6. Piping in mechanical room
